# The Bagdad Village Historic District Report & Maps

By Sara Campney & Krystal Caylor  
Santa Rosa County Planning & Zoning

## Bagdad Village Historic District Assessment

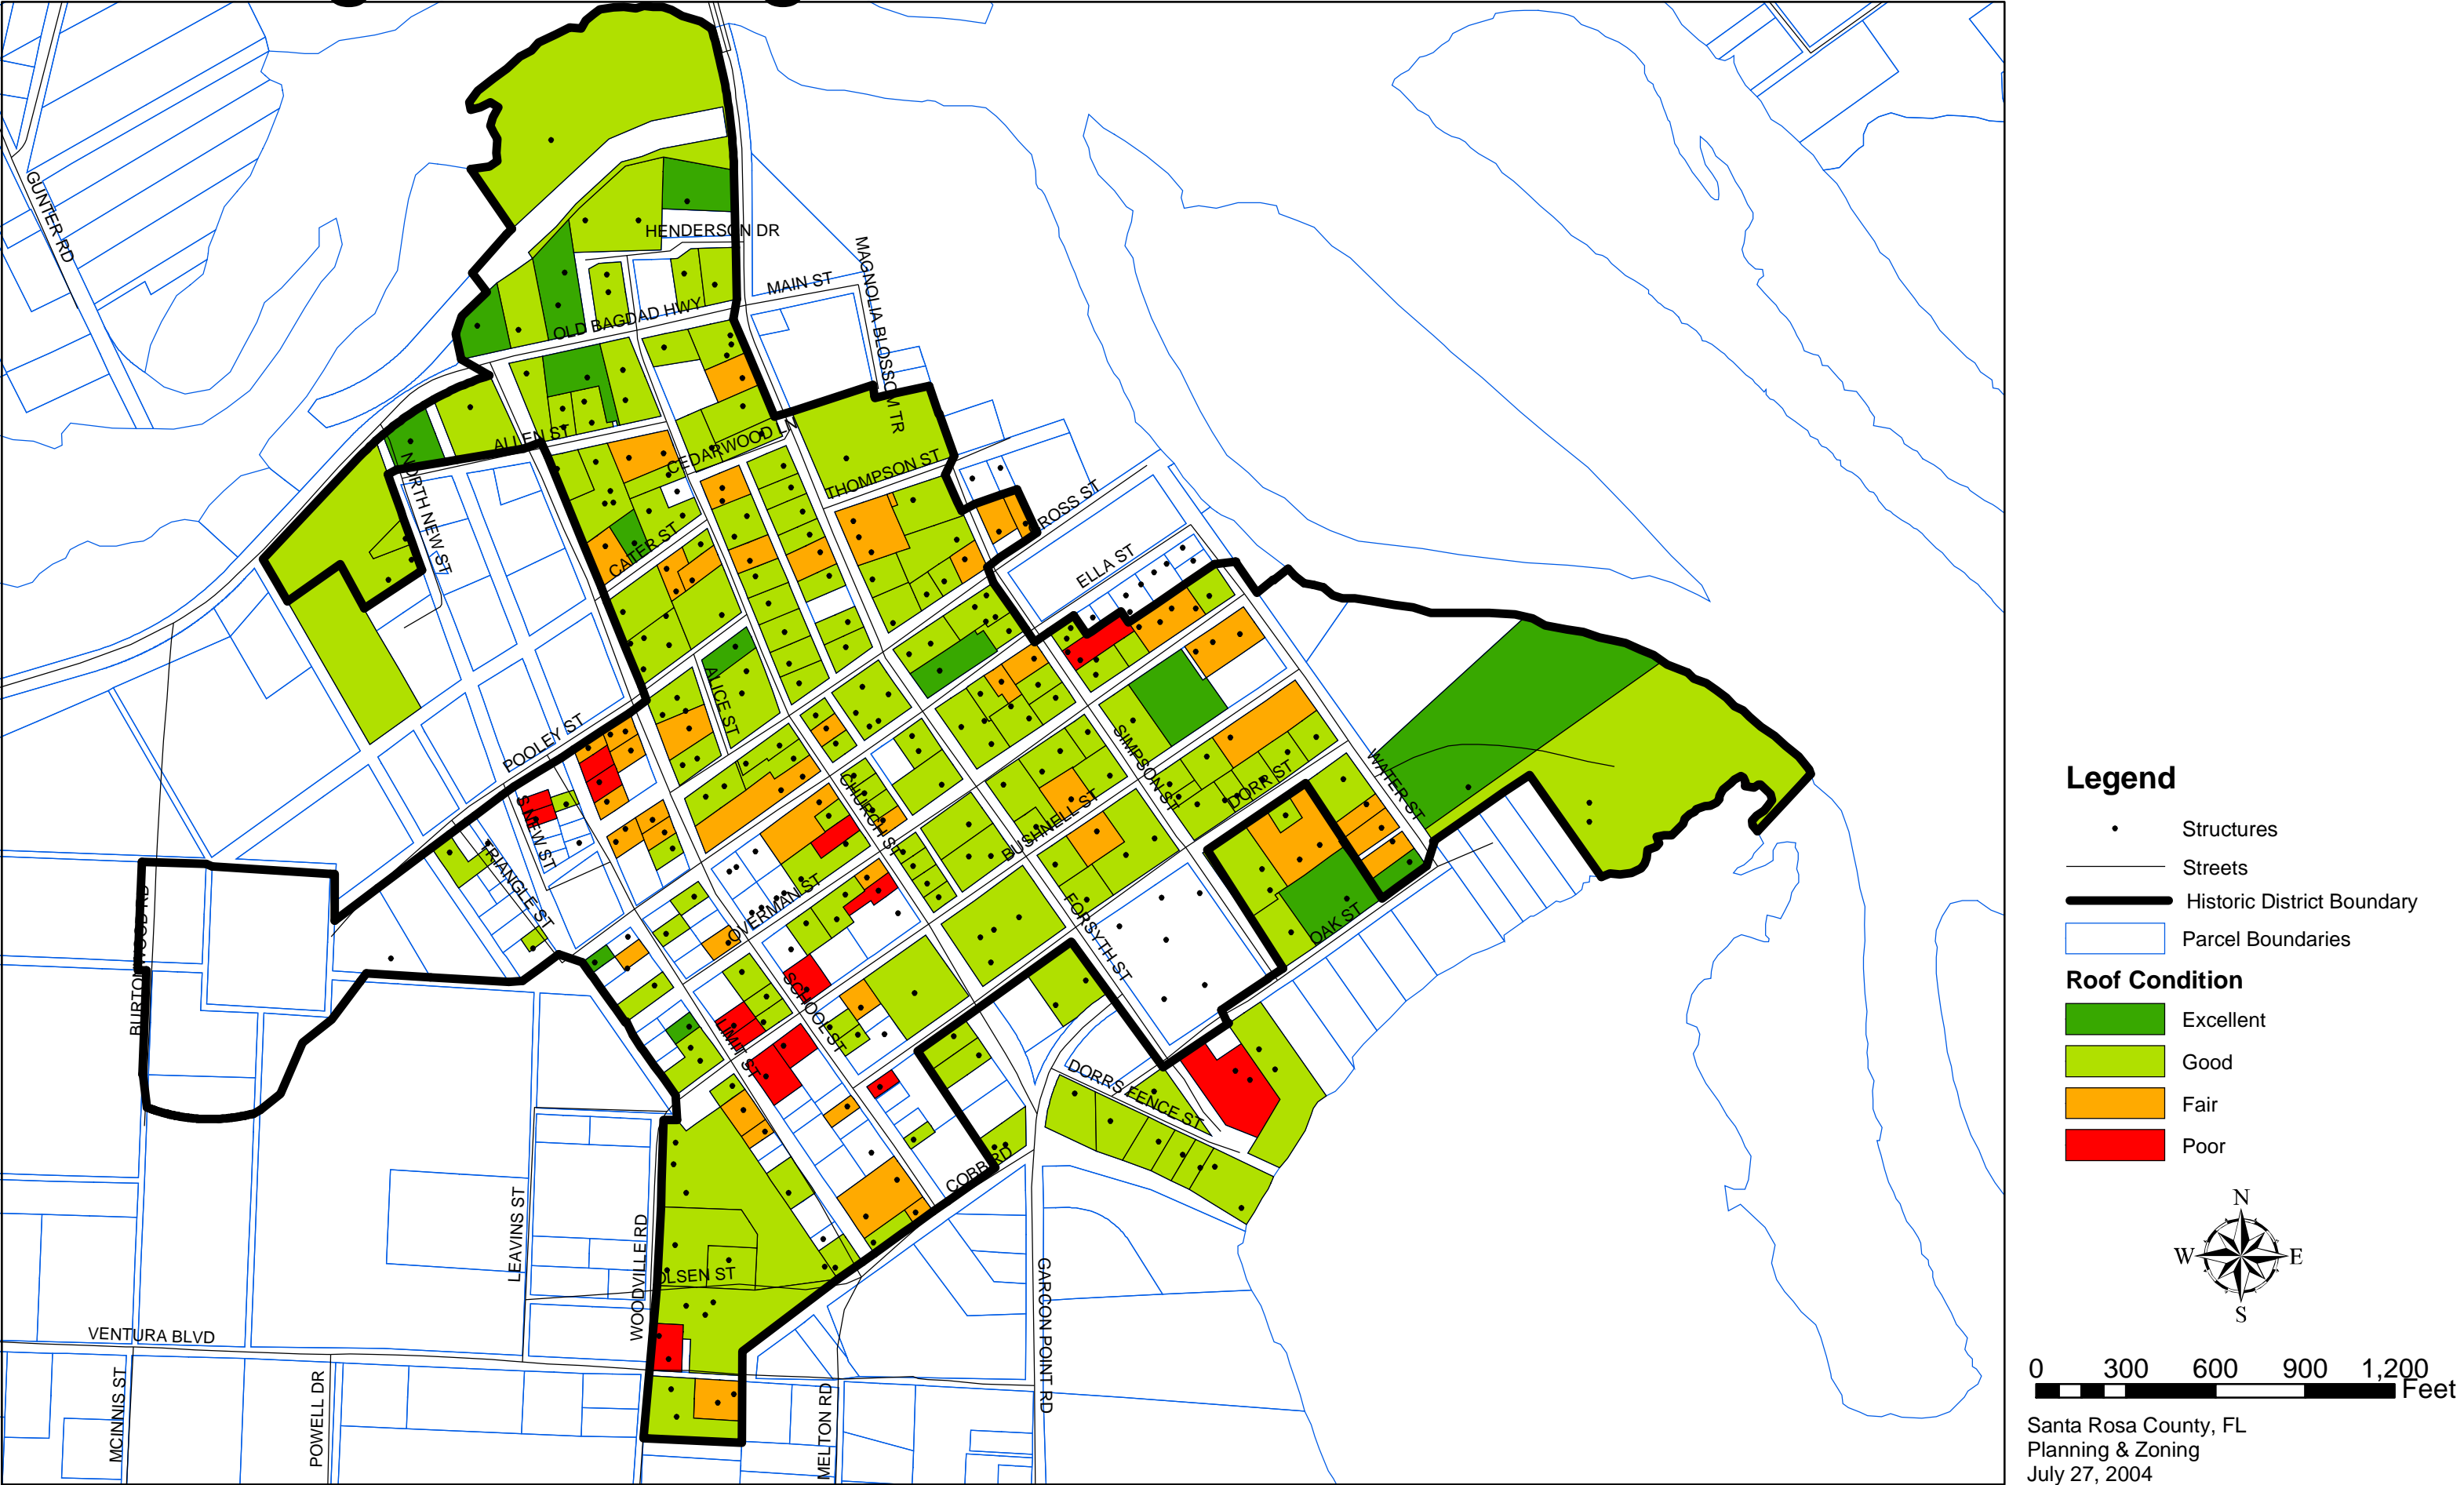
# Bagdad Village Historic District Roof Condition

Even though the majority of structures in the Historic District are being kept up, the structures which have fair or poor conditions on structural elements are important because they indicate the impending loss of historic resources. Several of the structures in this condition are geographically concentrated. A major concentration of homes that need repair is along Limit St. and the south block of School St (See Figures C-2, C-3, C-4, and C-5). Otherwise, only certain properties have significant structural problems.
